# PUMP Test REPORT

## Certified Performance Test for New Rotor Assembly

Hydro's Test Lab partnered with Hydro's Madison facility to quantify the performance of a newly rebuilt rotor assembly for a nuclear power plant. The plant had been experiencing degradation in the pump's performance.

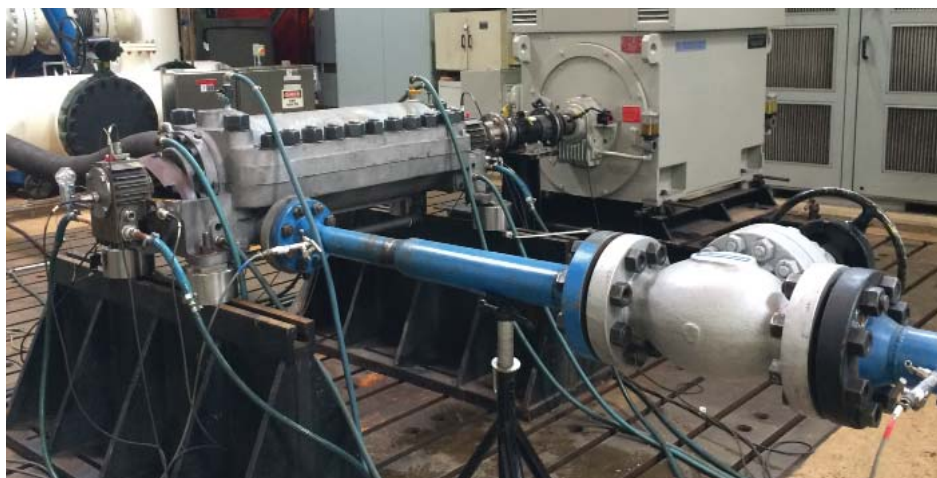
Several Certified Performance Tests (CPT) were completed at the rated speed of the pump in order to verify and re-verify the pump's performance. In order to account for field specific gravity, the performance curve was corrected from the test specific gravity (water = ~1.00) to the field conditions. Using historical pump performance data, the CPT tests compared the real-time data with the expected performance of the pump.

A Net Positive Suction Head (NPSH) test also verified the theoretical NPSH curve for the pump at five flow points ranging from maximum flow (150% of BEP) to minimum flow (roughly 50% of BEP).
